**December  
2016**

# **Montana State Capitol Exterior ADA Transition Plan**

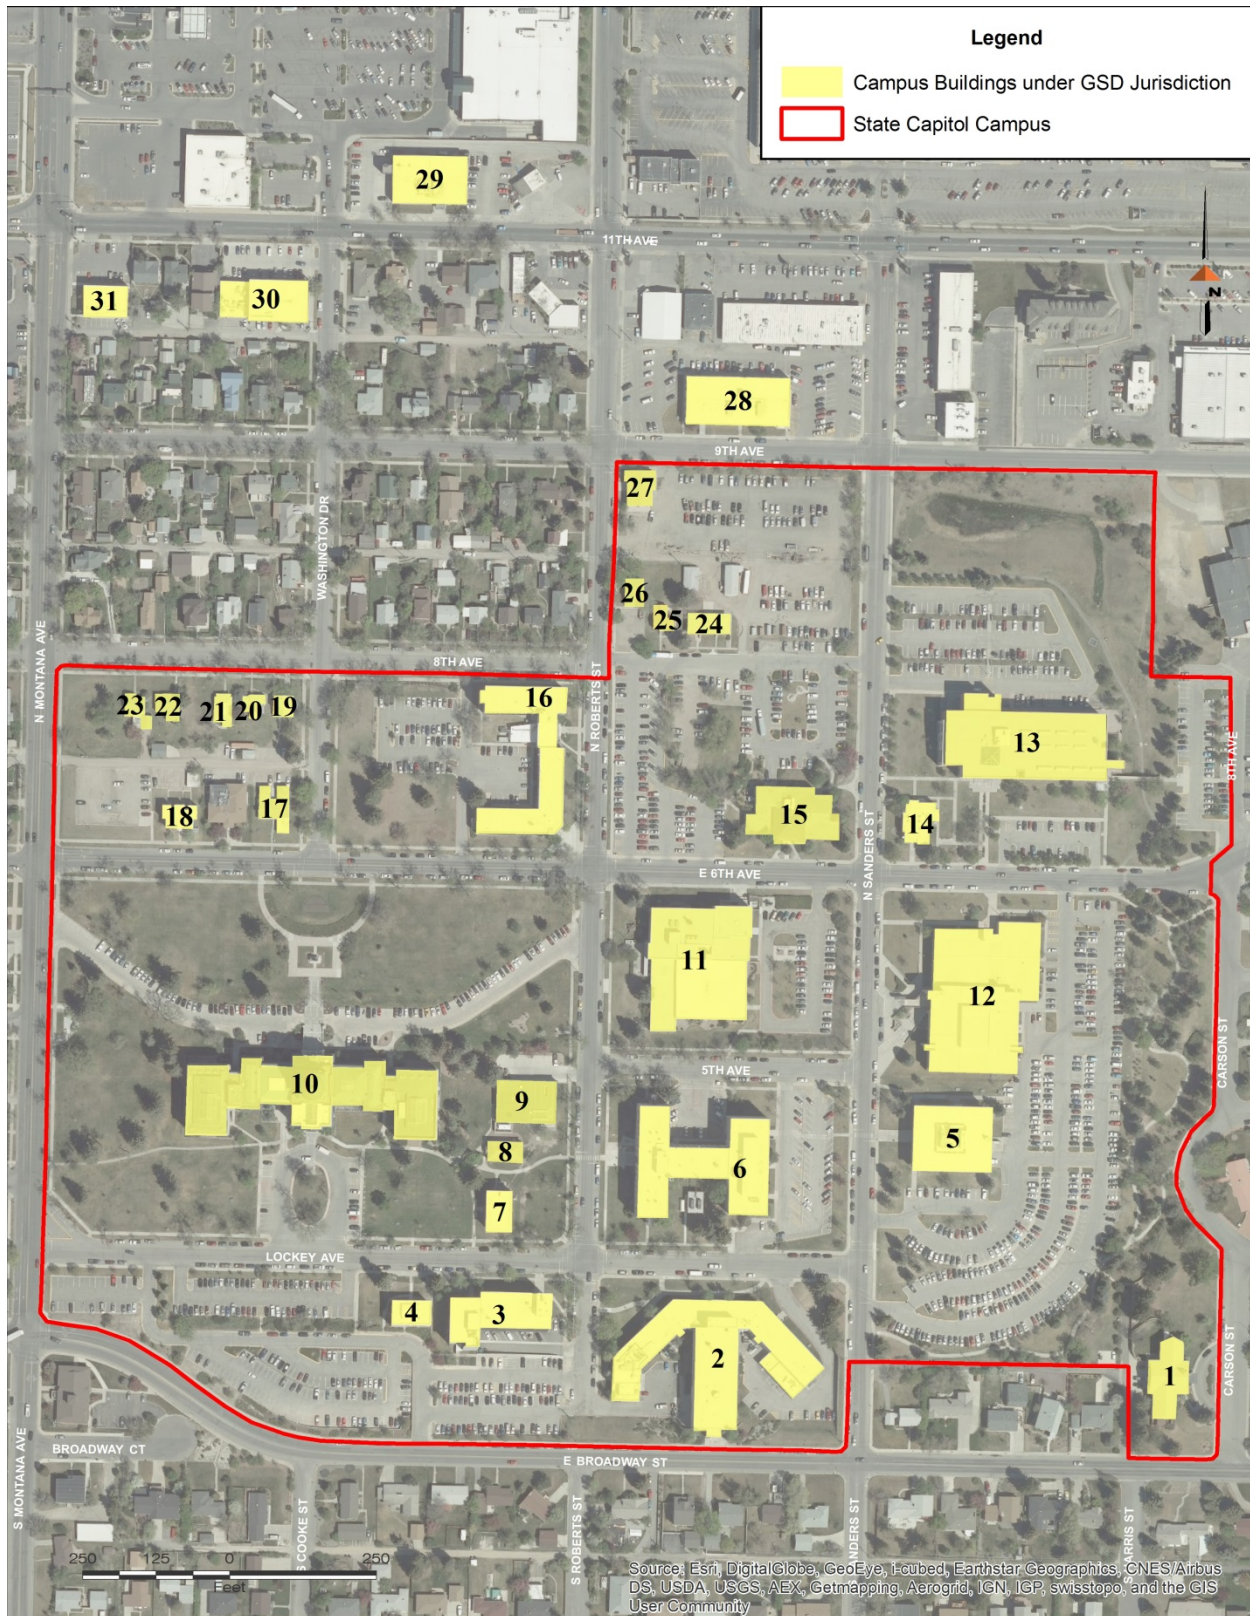
Figure 1 State Capitol Campus

Figure 1 illustrates the boundary of the State Capitol campus. Campus buildings under GSD jurisdiction are labeled according to Table 1.
